Manhole Inspection Summary

Manhole # S49EE_032MH

Insp Date: **7/16/08 10:02 AM**

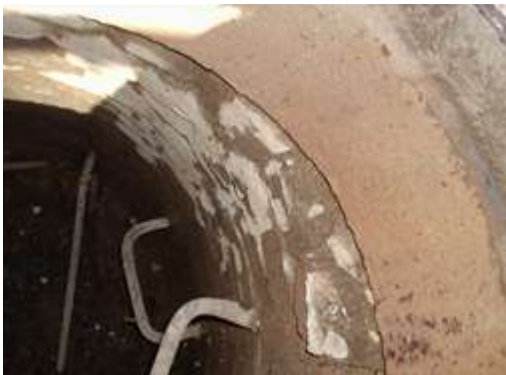
Defect 2

frame leaks

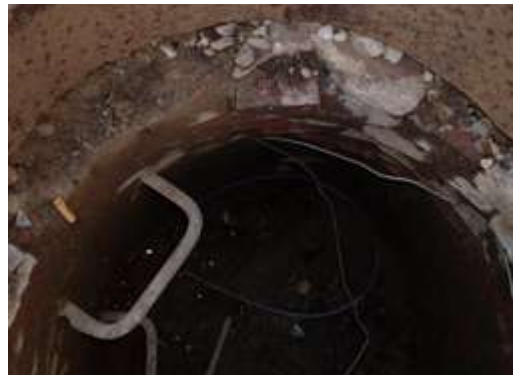
Defect 1

Infiltration: ☐ None ☒ **Joint** ☐ Cracks ☒ **Mortar** ☐ Roots ☐ Wall

infiltration

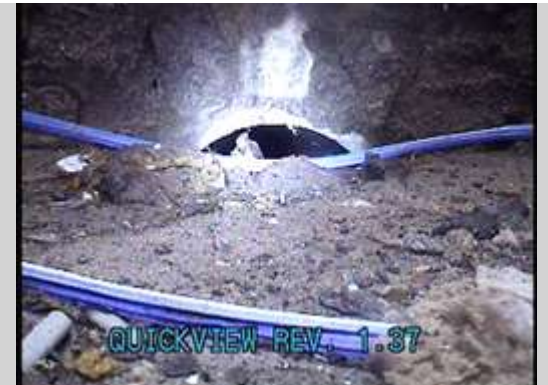
12 O'Clock Outflow

8 in. Circular Gravity Sewer
Pipe Out @ 12 O'Clock

Infiltration: **None** Pipe Seal Cond: **Sound**
